Це повідомлення містить важливі оновлення щодо глобального добровільного відкликання стентових систем імплантації для торакального відділу Медтронік Валіант Навіон, про яке було повідомлено у лютому 2021 р.

ОНОВЛЕНА ІНФОРМАЦІЯ ЗА РЕЗУЛЬТАТАМИ СПОСТЕРЕЖЕННЯ ЗА СИСТЕМОЮ НАВІОН

A preliminary analysis of late structural failures of the Navion stent graft in the treatment of descending thoracic aortic aneurysms

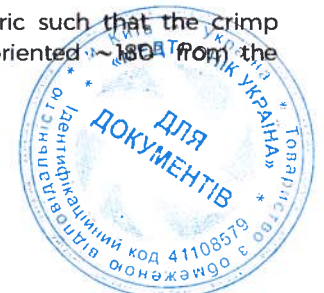
Fig 1. A, Construction of the Valiant Navion stent graft with the cross-section view showing the stent rings sewn with the crimps located $\sim 180^\circ$ from the graft seam. Also, a radiopaque side marker is nearly equidistant between the seam and crimps (red circle). B, View of a graft with the seam running down the length of the graft (blue arrows). C, View showing a line of crimps on the other side of the graft (green arrows).

Valiant Navion thoracic stent graft design and relevance to imaging findings. The Valiant Navion stent graft is constructed from a sheet of multifilament polyester sewn into a cylindrical shape, resulting in a seam line running along the length of the graft (Fig 1). The graft also has a series of stent rings that are formed by joining two ends of a stent ring with a cylindrical crimp sleeve. The stent rings are formed at a larger diameter (~20%) than that of the graft fabric diameter and sewn to the outer surface of the graft fabric such that the crimp sleeve on each stent ring is oriented ~180° from the seam line (Fig 1).

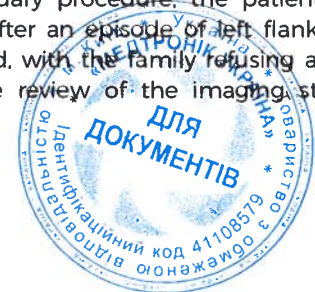
Fig 2. Patient 1. **A**, Computed tomography angiography (CTA) at 44 months after treatment showing contrast outside the stent graft profile (*blue arrow*) indicative of a type IIIb endoleak. **B**, Angiogram showing the side marker (*red circle*) identified and crimps evident along the inner curvature (*green arrows*). These findings indicate the graft seam is on the outer curvature and coincident with the location of the fractured stents (*blue arrows*).

The patient was admitted 44 months after the index procedure for acute left chest pain. CTA showed a type IIIb endoleak (Fig 2, A) and an aneurysm sac increase of >1 cm. Angiography confirmed blood flow outside of what should have been the cylindrical stent graft boundary (Fig 2, B). A secondary procedure was performed to reline the graft, and the type IIIb endoleak was successfully excluded with no evidence of any endoleaks. Four days after the secondary procedure, the patient was found unresponsive after an episode of left flank pain and pronounced dead, with the family refusing an autopsy. A retrospective review of the imaging studies

From the combination of CTA scans and angiography, it was evident that the stent graft fractures coincided with the location of the seam line of the graft. On the angiogram ([Fig 2, B](#)), the side marker was identified in the middle of the aorta, with the crimps visible along the inner curvature. This confirmed that the seam line was on the outer curvature where the stents had fractured. The three-dimensional CTA reconstructions ([Fig 3](#)), performed between 24 and 41 months after the index procedure, showed that four stent rings had fractured, with an additional stent ring fracture that occurred between 41 and 44 months. Stent ring enlargement had occurred as early as 24 months after initial treatment.

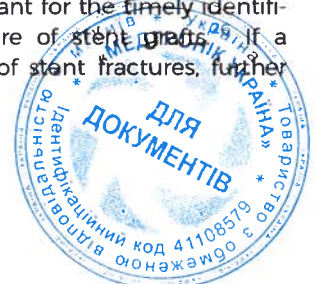
Fig 4. Patient 4. **A,B**, Three-dimensional computed tomography angiography (CTA) reconstruction showing the distance between the distal edge of the graft and distal edge of the celiac artery had increased by 17 mm by the 12-month imaging follow-up. The bottom three stent rings had fractured by the 49-month CTA study (**C**), and the fractured stents were also clear on the 51-month chest radiography (**D**).

imaging studies at 1 and 12 months showed that the distance between the distal end of the graft and the distal edge of the celiac artery had increased by 17 mm (from 19 mm to 36 mm; [Fig 4, A and B](#)). The core laboratory did not consider this a distal migration owing to the corresponding increase in the centerline length of the thoracic aorta.

At 49 months, the patient had new findings of pulmonary malignancy and was referred for further evaluation. In the 49-month imaging study ([Fig 4, C](#)), stent rings 9, 10, and 11 of the distal graft were found to have fractured, coincident with the location of the graft seam line. The findings were further confirmed by the 51-month chest radiograph ([Fig 4, D](#)). Because the patient elected to undergo partial pneumonectomy and adjuvant therapy, reintervention for the stent fractures and type IIIb endoleak was deferred. At the last follow-up visit, the patient was scheduled for additional imaging studies and a planned endovascular reintervention.

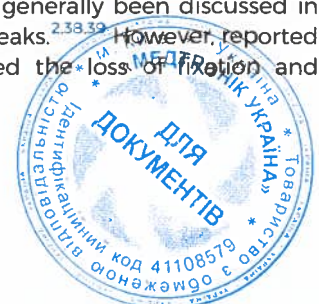
Fig 5. Patient 11. Computed tomography angiography (CTA) showing stent ring enlargement that occurred between 12 and 48 months. The stent appears to have detached from the fabric, although this did not lead to a type IIIb endoleak. The nominal stent graft diameter was 43 mm; the seam location is marked by blue arrows.

observed (Fig 5). The patient was asymptomatic with no detected endoleaks, and further monitoring was planned.

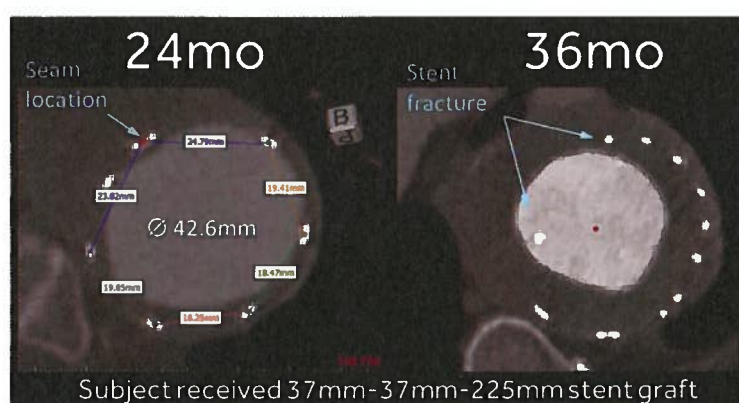
Stent Ring Diameters (mm) over Time

Ring no.	1 mo	12 mo	24 mo	36 mo
4	38	38	40	43
5	36	38	42	Fractured
6	38	38	39	Fractured
7	38	38	40	Fractured
8	37	38	38	Fractured
9	23	29	38	42

Subject received 37mm-37mm-225mm stent graft

Supplementary Fig 2 (online only). Patient 3 (type IIIb endoleak, stent fractures along seam line, and stent ring enlargement). The patient was a 65-year-old woman with a fusiform descending thoracic aortic aneurysm (DTAA) with diameter of 62 mm. The patient underwent implantation with a single Valiant Navion stent graft (37 mm, 37 mm, 225 mm) and a zone 3 proximal landing. On the 24-month imaging study, no endoleaks, stent fractures, or aneurysm enlargement was observed. However, the diameters of stent rings 4, 5, 6, and 7 had enlarged. **A**, Between the 24- and 36-month imaging studies, stent rings 5, 6, 7, and 8 had fractured, and stent rings 4 and 9 showed stent ring enlargement. **B**, The seam of the graft was identified at the inner curvature, and the fractures were in line with the graft seam shown on the cross-section computed tomography (CT) scan. At last follow-up, the patient was scheduled for an endovascular reintervention.

Patient 3 (type IIIb endoleak, stent fractures along seam line, stent ring enlargement). The details and images from patient 3 are shown in [Supplementary Fig 2](#) (online only).
